Waikato Building Report

46 Hamilton Gardens Obdam

Summary

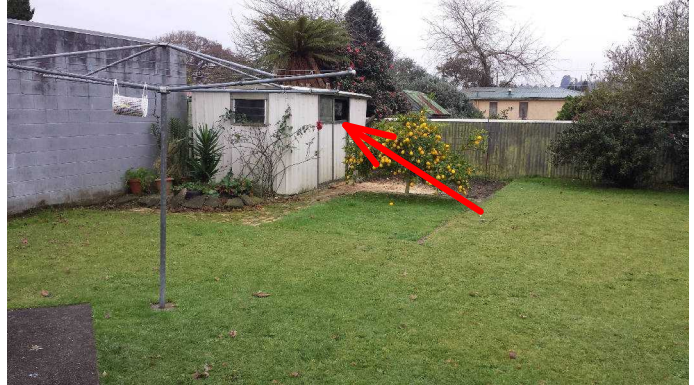
1. Garden Sheds: *Small garden shed* - *Glass missing*

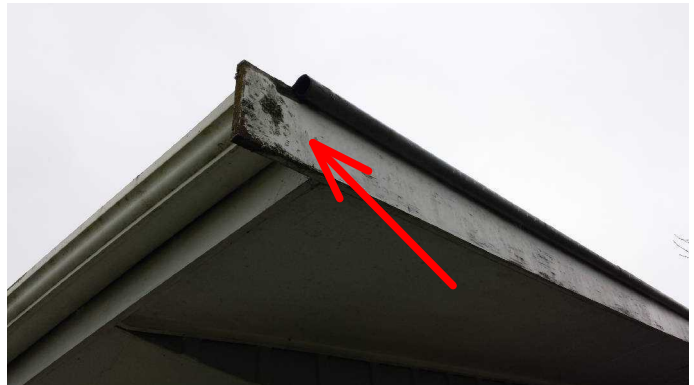
2. Fascia: *Painted timber* - *Paint peeling on most of the fascia boards*

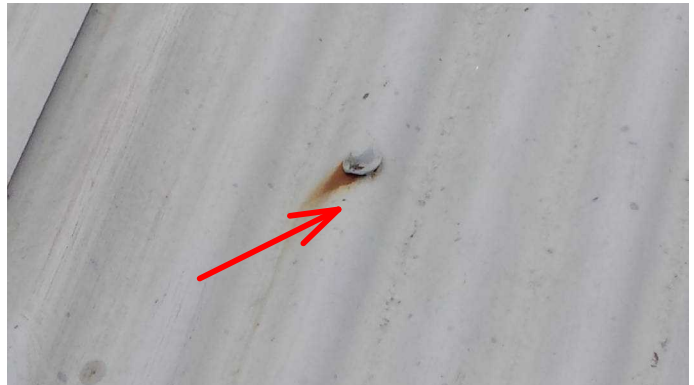
3. Roof Material: *Painted iron* - *Some loose nails.*

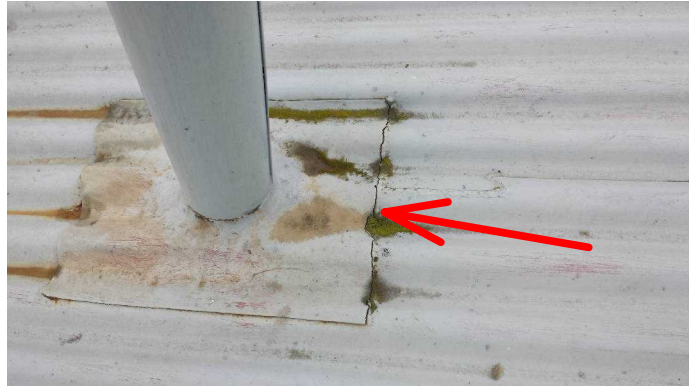
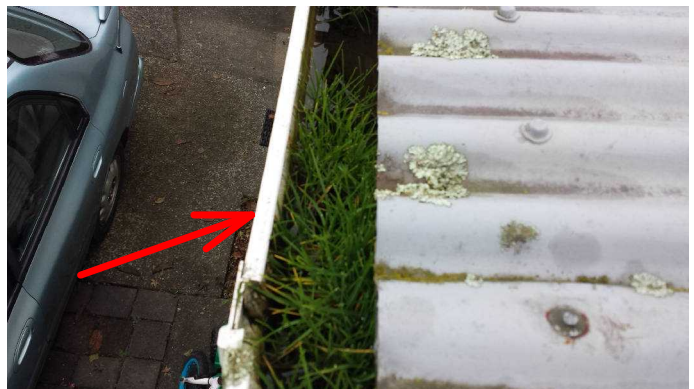
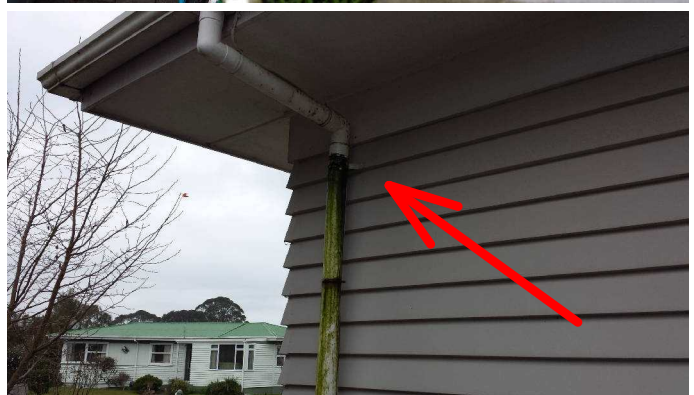
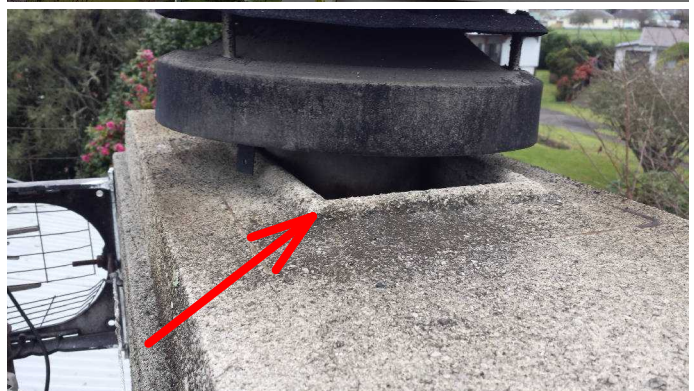
4. Flashings: *Lead* - *Cracked flashing behind the vent pipe*
5. Gutters: *PVC* - *Gutters have negative flow and are holding water. Needs cleaning.*
6. Downpipes: *PVC* - *Downpipe appears blocked or is seriously leaking outside kitchen*
7. Flue: *Metal* - *There should be a protective cover over the hole in the precast section to prevent water getting into the cavity space.*

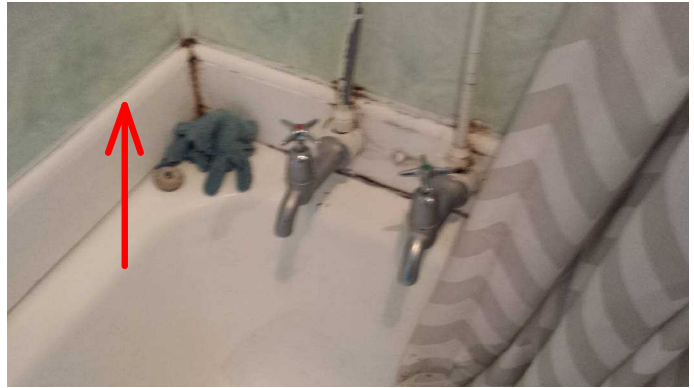
8. Off hallway Bathroom Walls: *Gib board, Water proof lining* - *I suspect that the timber around the edge of the bath is very wet and there is a strong possibility that water from the shower is running between the wall lining and behind at this timber*

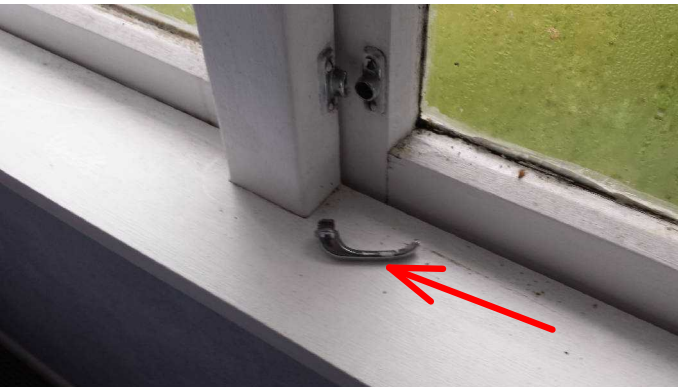
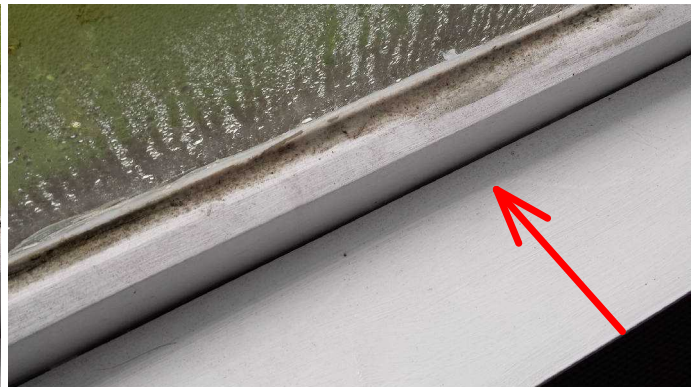
9. Off hallway, 3 bedrooms Bedroom Windows: *Timber framed, Single glazed* - *In the main bedroom window that faces the street the window latches are broken and the large section of window appears to be loose as there is a gap along the windowsill and the timber window frame*

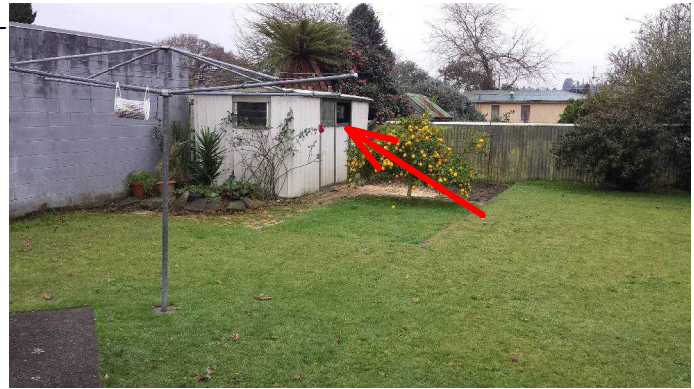
Acceptable Driveway: *Concrete*
Acceptable Patio and Paths: *Concrete*
Acceptable Fences: *Unpainted timber*
Acceptable Gates: *Painted timber*
Acceptable Hose Taps: *Tested and working*
Acceptable Section Run-off: *Flat*
Marginal Garden Sheds: *Small garden shed*
Glass missing

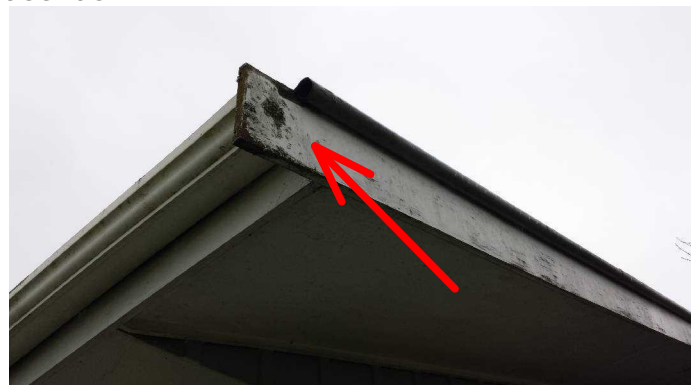
Acceptable Structure Type: *Timber framed*
Acceptable Foundation: *Concrete piles*
Acceptable Subfloor: *See separate category*
Acceptable Wall Cladding: *Painted Timber weatherboards*
Marginal Fascia: *Painted timber* - *Paint peeling on most of the fascia boards*

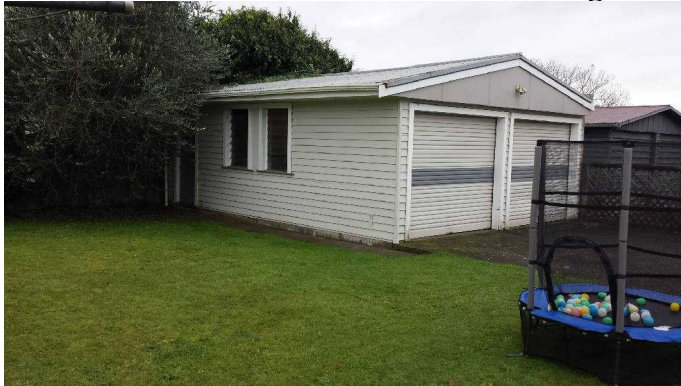
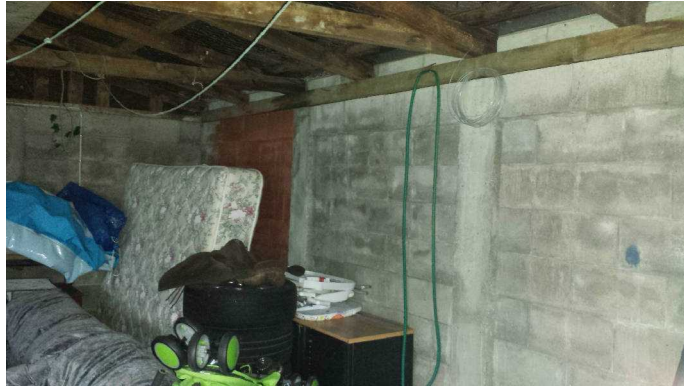
General Photos: *Trees need trimming*

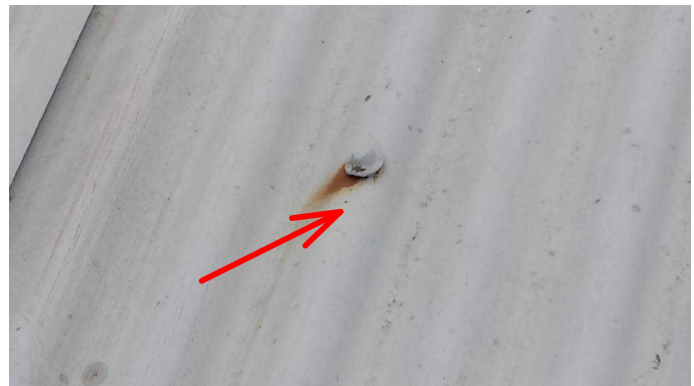
Marginal Roof Material: *Painted iron* - *Some loose nails.*

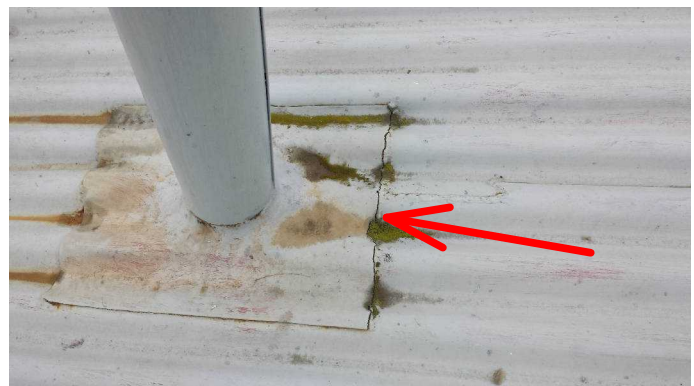
Marginal Flashings: *Lead* - *Cracked flashing behind the vent pipe*

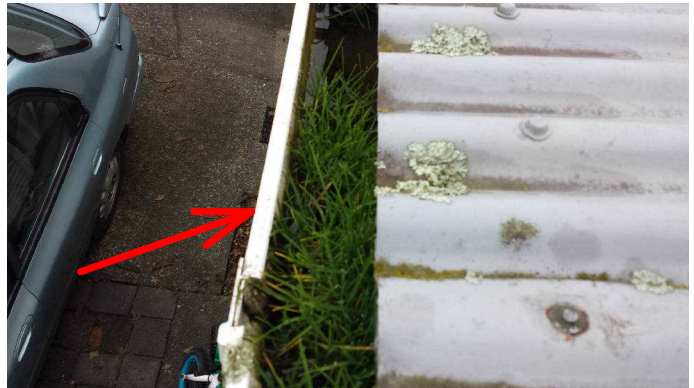
Gutters: *PVC* - *Gutters have negative flow and are holding water. Needs cleaning.*

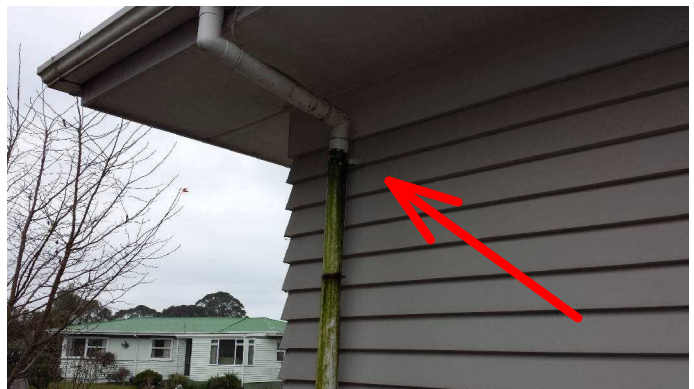
Downpipes: *PVC* - *Downpipe appears blocked or is seriously leaking outside kitchen*

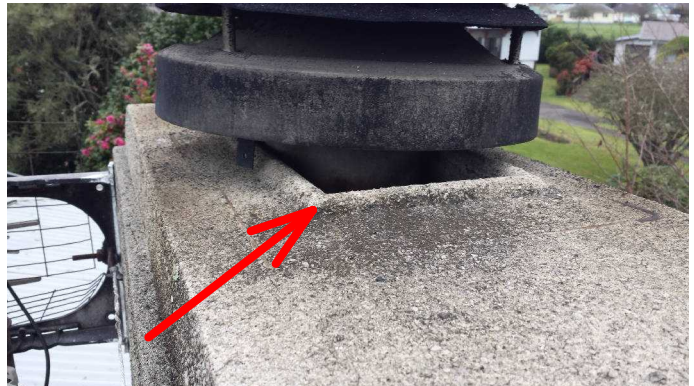
Chimney: *Pre-cast concrete*
Flue: *Metal* - *There should be a protective cover over the hole in the precast section to prevent water getting into the cavity space.*

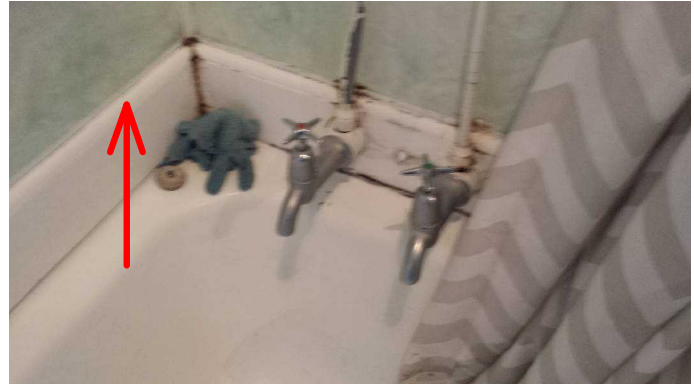
Acceptable Ceiling: *Gib board*
Marginal Walls: *Gib board, Water proof lining*
 - *I suspect that the timber around the edge of the bath is very wet and there is a strong possibility that water from the shower is running between the wall lining and behind at this timber*

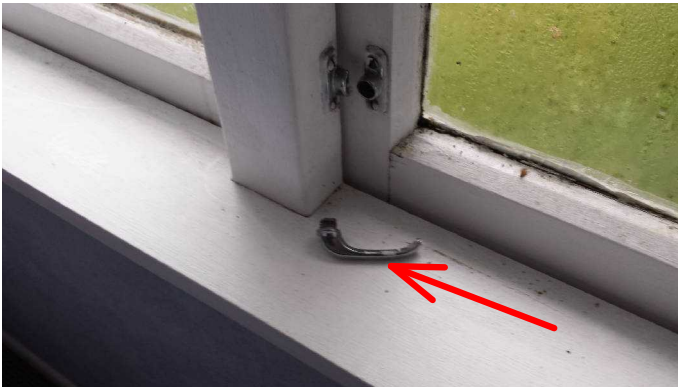
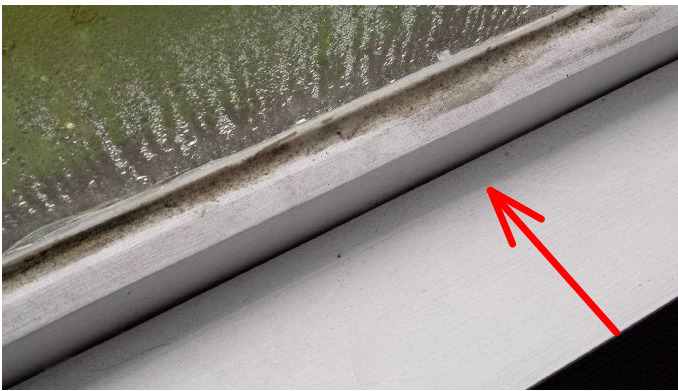
Marginal Windows: *Timber framed, Single glazed* - *In the main bedroom window that faces the street the window latches are broken and the large section of window appears to be loose as there is a gap along the windowsill and the timber window frame*
